Thermal failure in a clamping bolt of a shunt reactor

This article presents the detection and analysis of a thermal failure produced in a core clamping bolt of a 5 MVar gapped three-phase shunt reactor. Gases were detected in this shunt reactor during its operation at a substation in Mexico. Using dissolved gas analysis (DGA) and Duval's triangle method, temperatures up to 700°C were estimated in the shunt reactor. Overheating evidence was detected in one of the core clamping bolts during an internal inspection of the shunt reactor. The author and the reactor manufacturer believe that

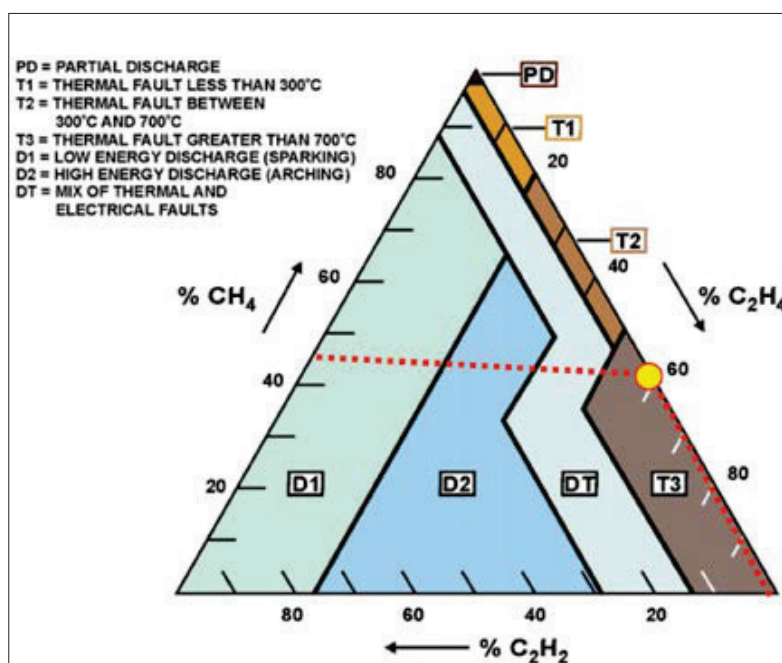
Figure 1. Identification of the thermal fault in the shunt reactor using Duval's triangle method

hydrogen (H₂), ethylene (C₂H₄), acetylene (C₂H₂), and methane (CH₄) were detected in the shunt reactor, indicating the presence of a possible high-temperature fault. Table 2 shows the dissolved gas analysis (DGA) results obtained in the shunt reactor [9]. A thermal fault was confirmed using Duval's triangle method and the DGA results of Table 2. From Duval's triangle, a thermal fault type T3 was diagnosed in this shunt reactor; see Figure 1. A thermal fault type T3 indicates a failure in insulating oil and/or paper above 700 °C with evidence of carbonized oil, with metal coloration or melting. The possible causes for these thermal faults could generate overheating regions, partial discharges, and sustained electric arcs [11]-[13]. Despite the detection of gases in the shunt reactor, the Mexican electric utility company and substation operators decided to run the failure of the shunt reactor, which never fully occurred.

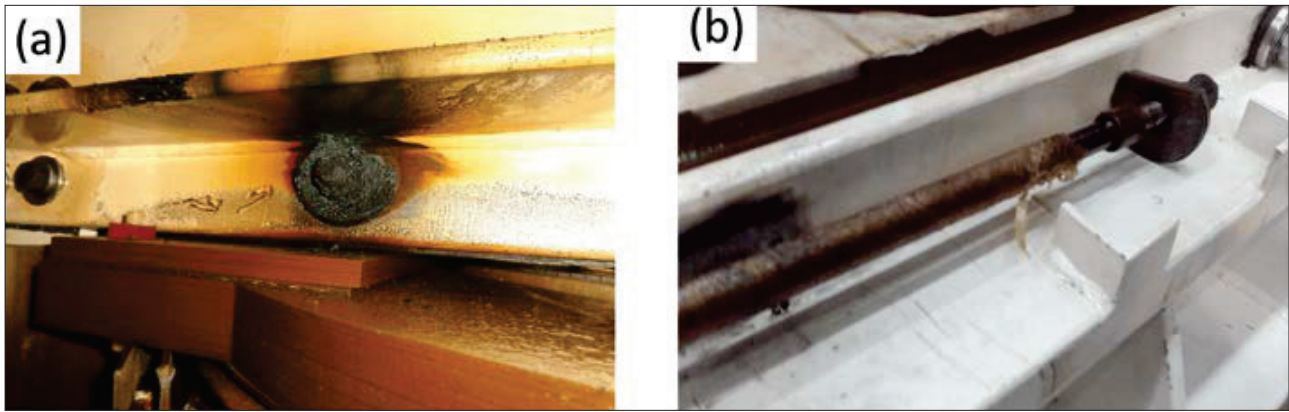
the insulation of the clamping bolt was damaged by the loosening of the bolts produced by the vibration of the shunt reactor in conjunction with a possible low torque applied to the bolts. A short circuit between the bolt and the clamping frame was produced, generating the circulation of eddy currents in the bolt producing high temperatures and gasifying the insulating oil in the shunt reactor. Three-dimensional (3-D) finite element (FE) simulations were performed to verify the cause of the overheating issue in the clamping bolt of the shunt reactor, simulating the short circuit between the clamping bolt and

Visible signs of overheating were found in the region of one of the non-magnetic stainless steel clamping bolts in one of the top low-carbon steel clamping frames of the shunt reactor

The carbonized residue of insulation was found around the bolt region, with more found on the top coil region. The clamping bolt was removed from the top frame, and the manufacturer discovered that an important part of the insulation along the bolt had been damaged and destroyed, leaving the bolt bare, see Figure 2 (b). Generally, several layers of insulating paper are employed to insulate the clamping bolts from the core yokes and frames. The insulation along the bolt prevents possible contact between the bolt and the core frames and contact between the bolt and the magnetic core laminations. The author and manufacturer believe that the main cause of the damaged bolt insulation was produced by the loosening of the bolts produced by the vibration of the shunt reactor in conjunction with a low torque applied to the bolts during the tightening process [14]. The reactor vibration loosened the clamping bolt, damaging and destroying its insulation and producing a short circuit between the core frame and the bolt, generating the circulation of a high current in the bolt and generating high temperatures in the bolt-frame region. Thermal faults have been detected in high-voltage shunt reactors due to vibrations [15], [16].

Figure 2. a) Bolt and frame with signs of overheating, b) insulation of the bolt destroyed [9]

Based on the simulation results, the manufacturer decided to repair the shunt reactor, reinforcing the insulation of all the stainless-steel clamping bolts with several layers of fiberglass to prevent future short-circuit failures. In addition, the manufacturer replaced all the pressboard spacers with thick fiberglass spacers, and a bolt torque of 57 Nm was verified for all the bolts during the tightening process. Finally, the temperature of the repaired shunt reactor was monitored and tested in the high-voltage laboratory before shipping the shunt reactor to the customer.

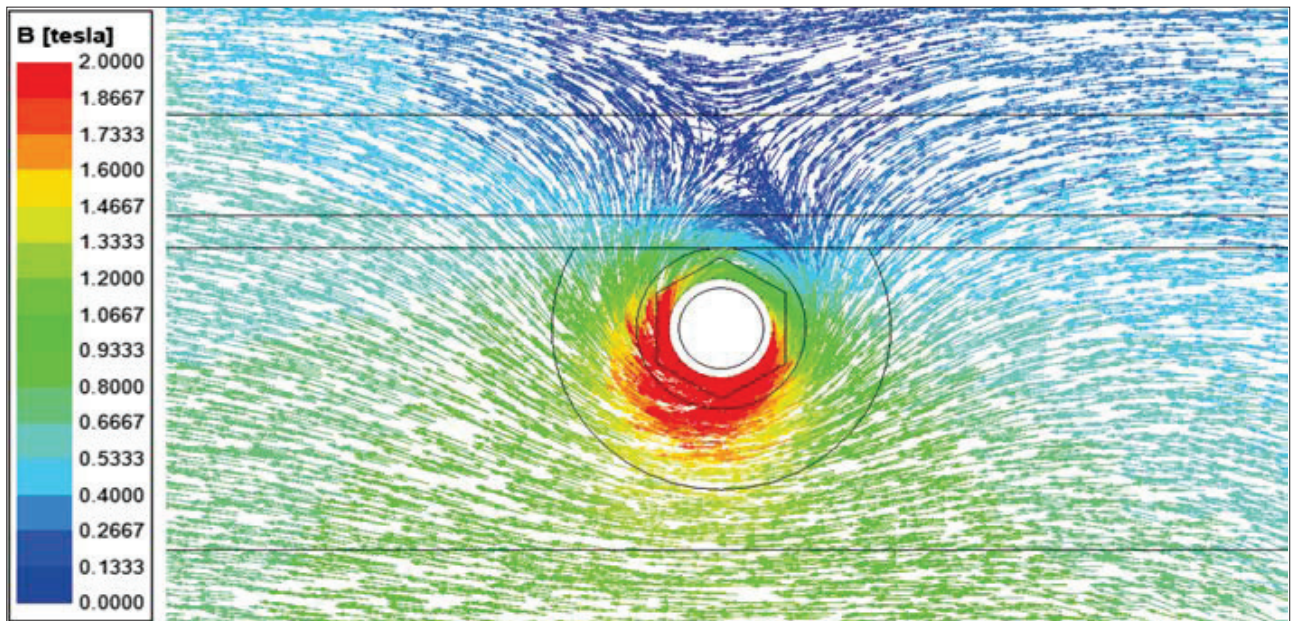
them. For this reason, these bolts are omitted in the model of Figure 3. A current density of 130 A/cm² and a short circuit current of 160 A were computed in the clamping bolt under short circuit conditions. This current circulates in the bolt, passing through the magnetic core holes. This current produces a small and saturated region with a magnetic flux density of 2 T around the magnetic core holes, see Figure 4.

Figure 4. Magnetic field distribution in the magnetic core region around the magnetic core hole

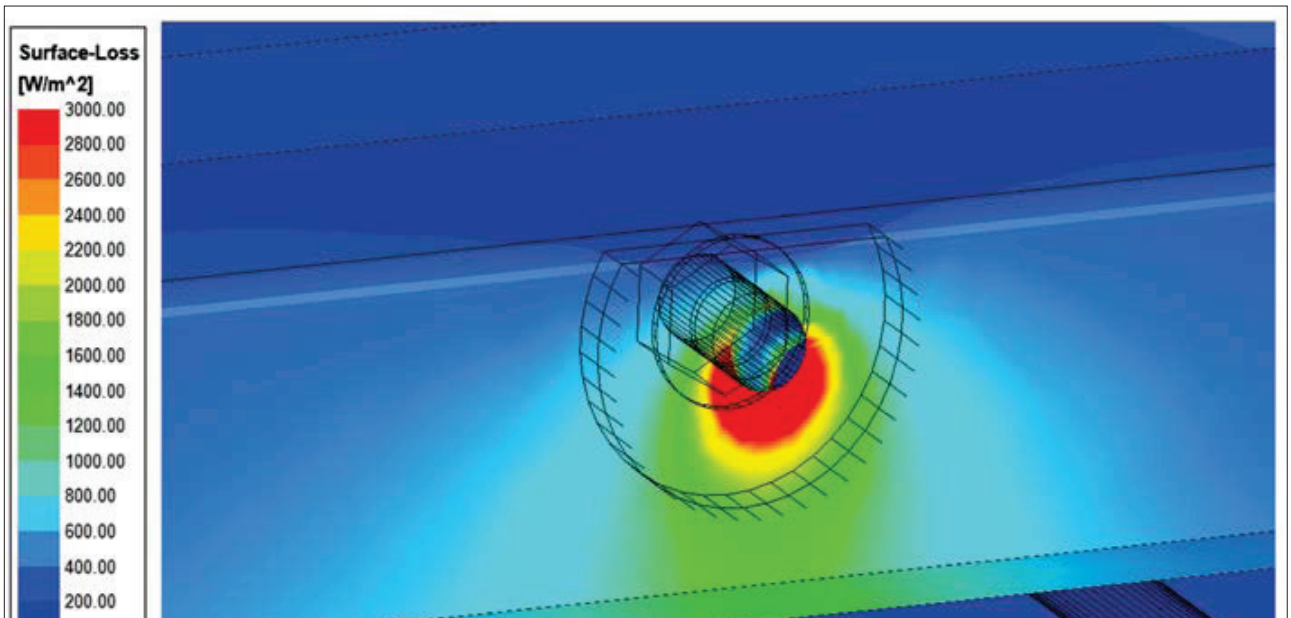
Figure 5 shows the loss density distribution in the clamping frame region. A maximum loss density of 3000 W/m² was computed in the frame region in the bolt-hole region. Figure 6 shows the current

Figure 5. Loss density distribution in the bolt-frame region

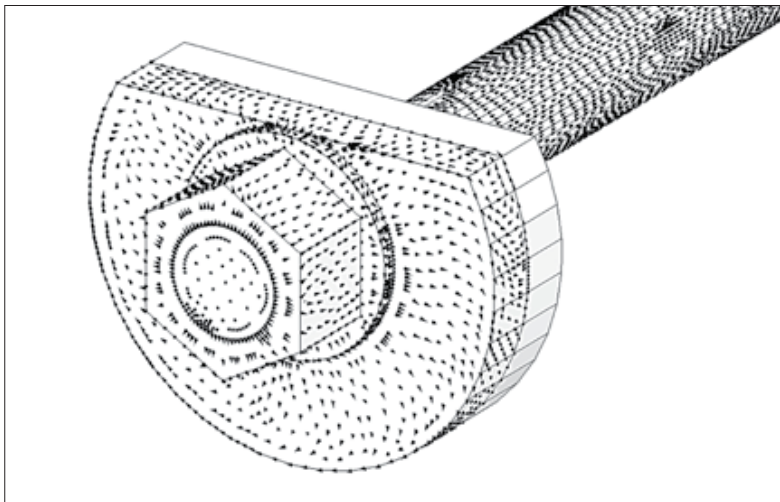
A current density of 130 A/cm² and a short circuit current of 160 A were computed in the clamping bolt under short circuit conditions

Figure 6. Short circuit currents circulating in the clamping bolt

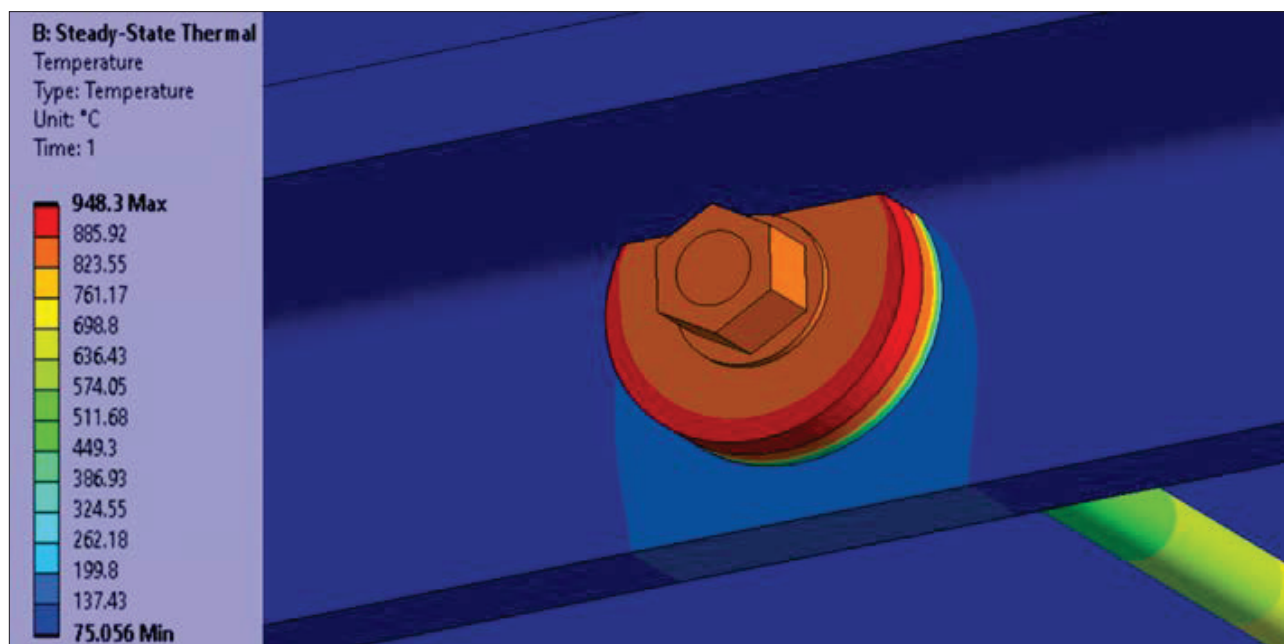
Figure 7 shows the temperature distribution during the presence of the short circuit current in the clamping bolt. The bolt reached an average temperature of 850 °C and a maximum temperature of almost 950 °C. The poor circulation of the oil in the bolt-magnetic core region helped to increase the temperature of the bolt.

Figure 7. Temperature distribution in the clamping bolt and frame region
