Thermal failure in a clamping bolt of a shunt reactor

This article presents the detection and analysis of a thermal failure produced in a core clamping bolt of a 5 MVar gapped three-phase shunt reactor. Gases were detected in this shunt reactor during its operation at a substation in Mexico. Using dissolved gas analysis (DGA) and Duval's triangle method, temperatures up to 700°C were estimated in the shunt reactor. Overheating evidence was detected in one of the core clamping bolts during an internal inspection of the shunt reactor. The author and the reactor manufacturer believe that

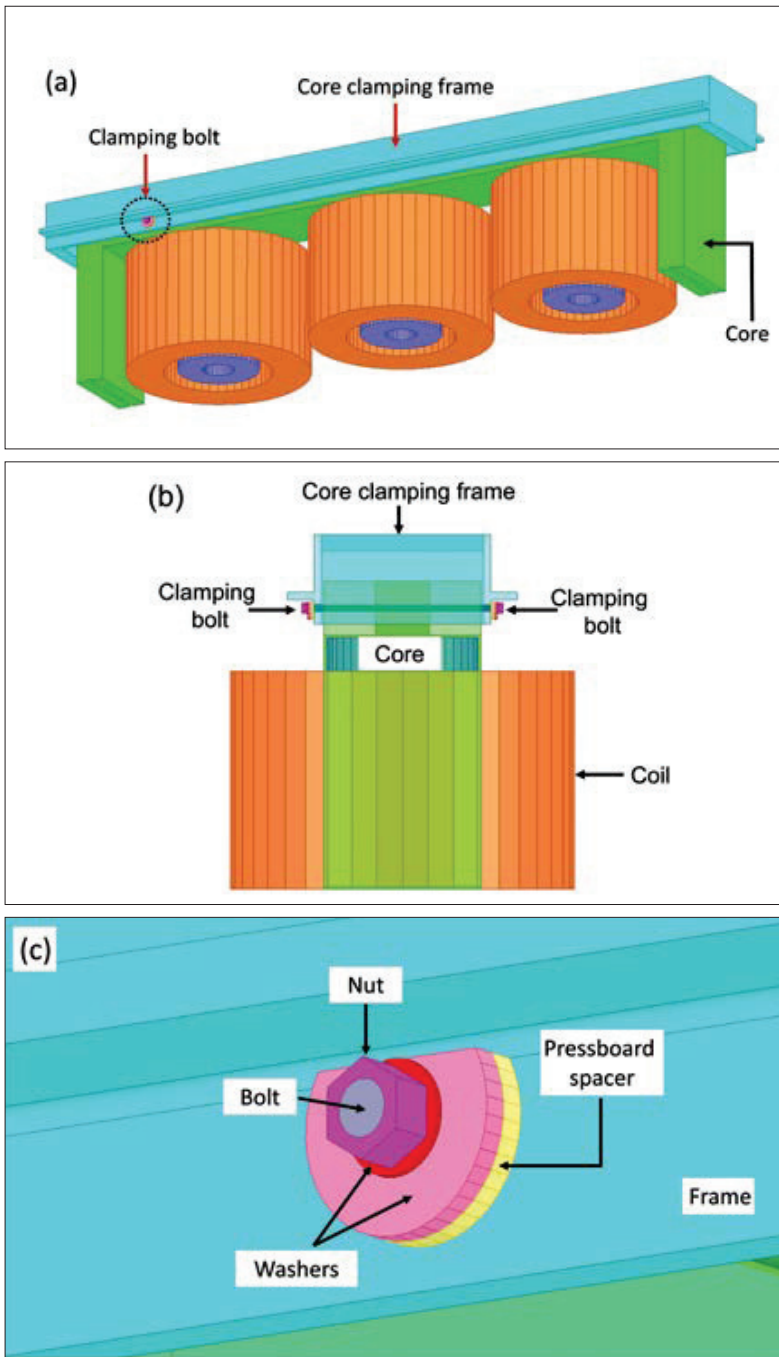
Figure 3. a) shunt reactor model, b) lateral view of the shunt reactor model, c) view of the clamping bolt region

The interest regions of the 3-D shunt reactor model are presented in Figure 3. The coils of the shunt reactor are made of copper conductors, and the magnetic core

them. For this reason, these bolts are omitted in the model of Figure 3. A current density of 130 A/cm² and a short circuit current of 160 A were computed in the clamping bolt under short circuit conditions. This current circulates in the bolt, passing through the magnetic core holes. This current produces a small and saturated region with a magnetic flux density of 2 T around the magnetic core holes, see Figure 4.
